PROPERTY BASELINE SCAN

1234 Sample St.

3.17.2020 Inspection

Roofing Overview

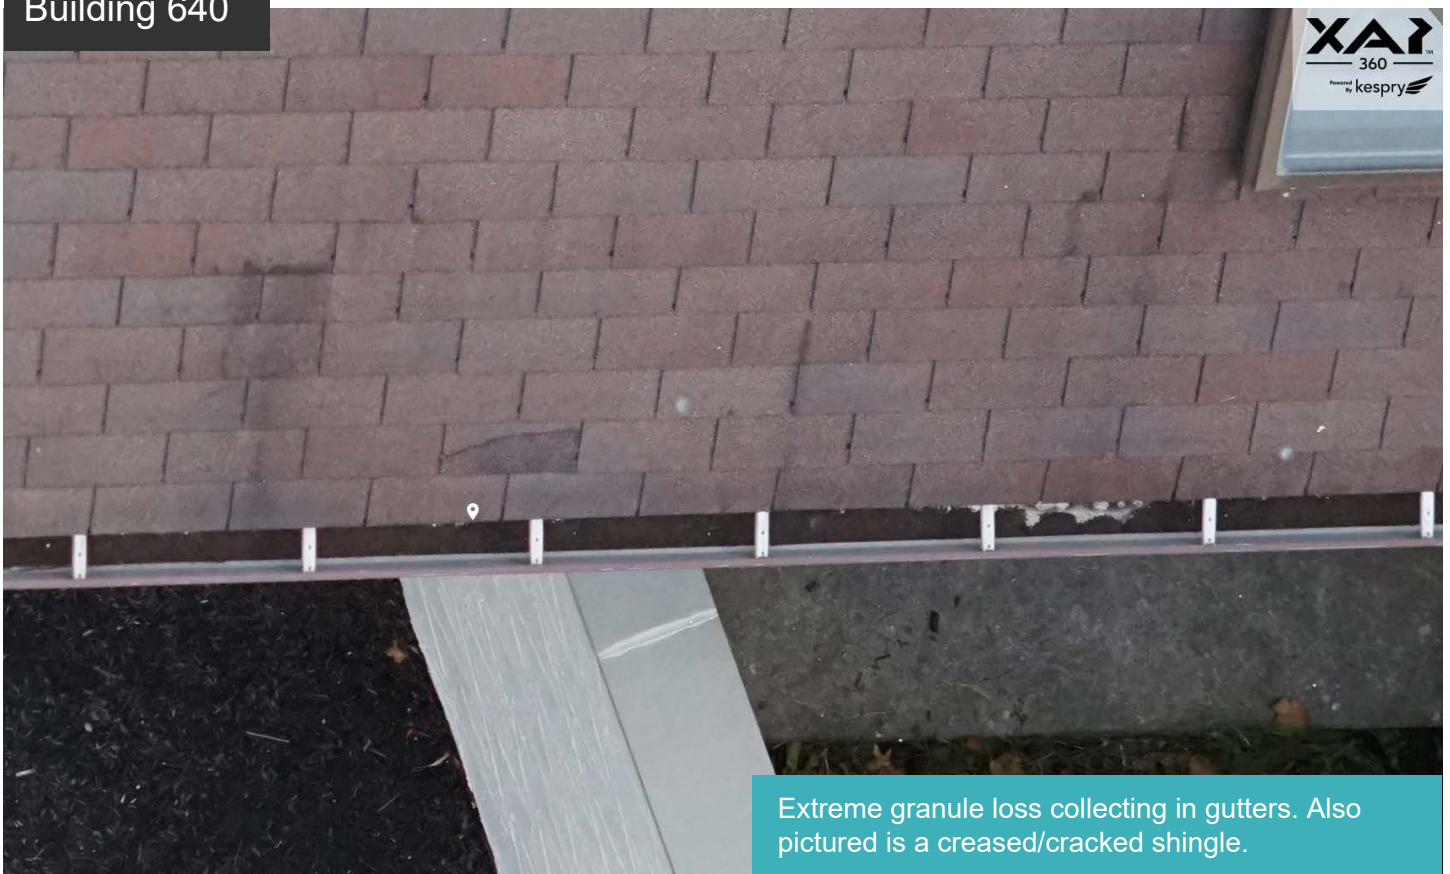
Building 640

Extreme granule loss collecting in gutters. Also pictured is a creased/cracked shingle.

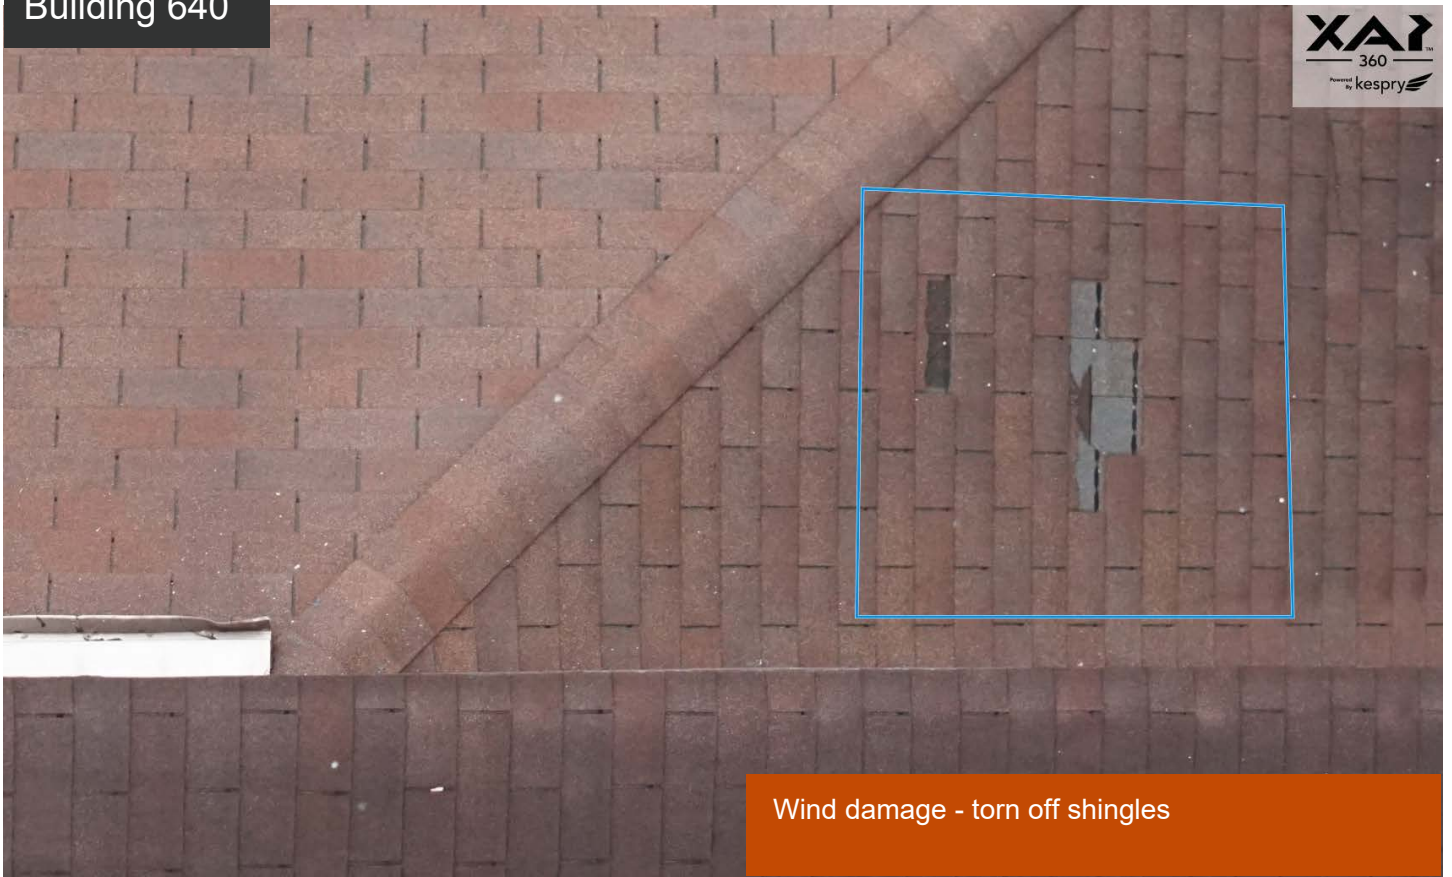
Building 640

Wind damage - torn off shingles

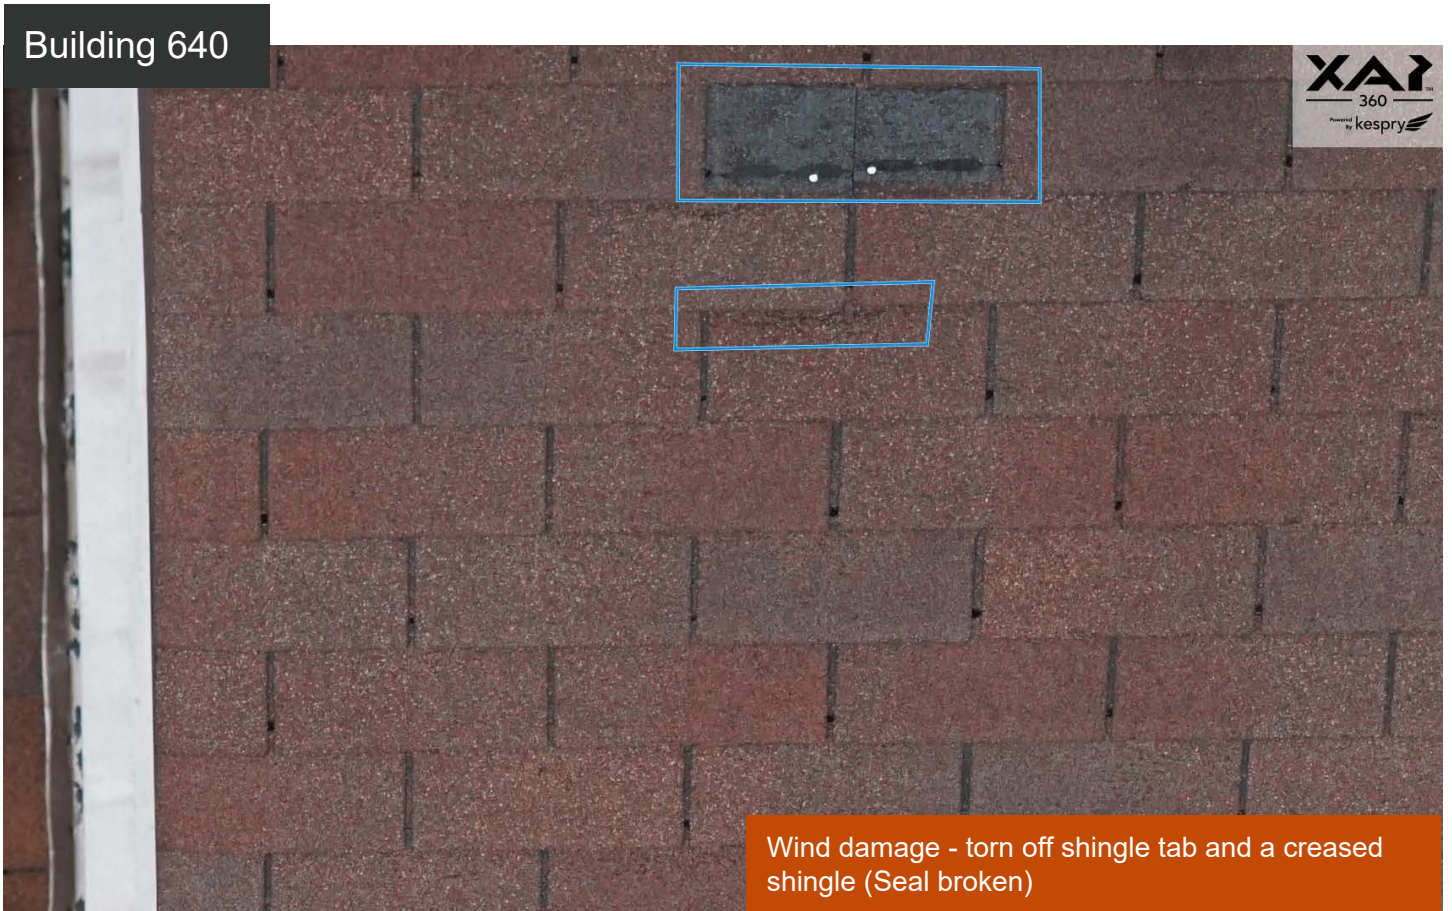
Building 640

Wind damage - torn off shingle tab and a creased shingle (Seal broken)

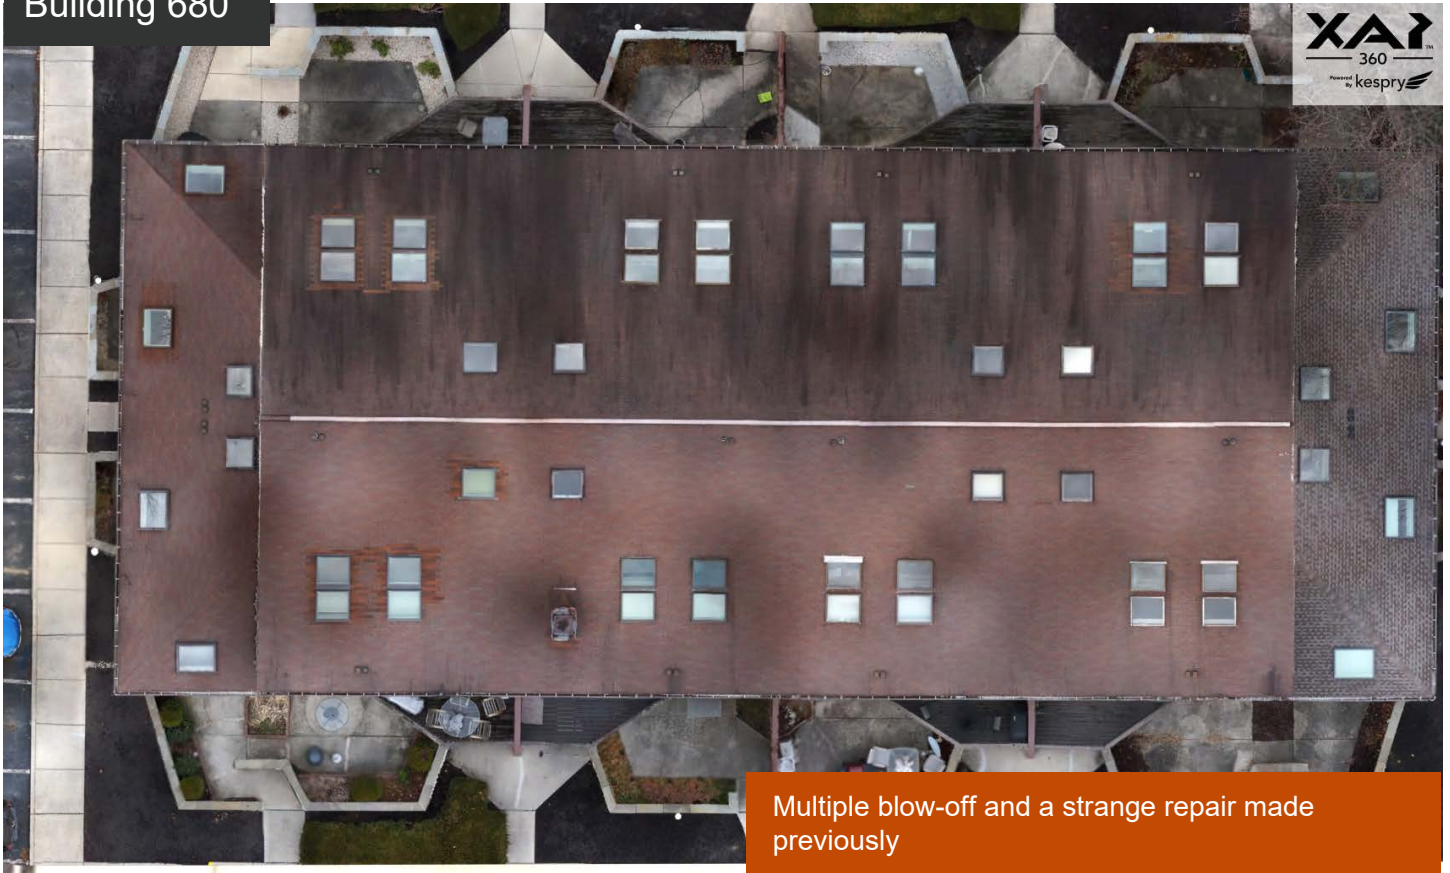
Building 680

Multiple blow-off and a strange repair made previously

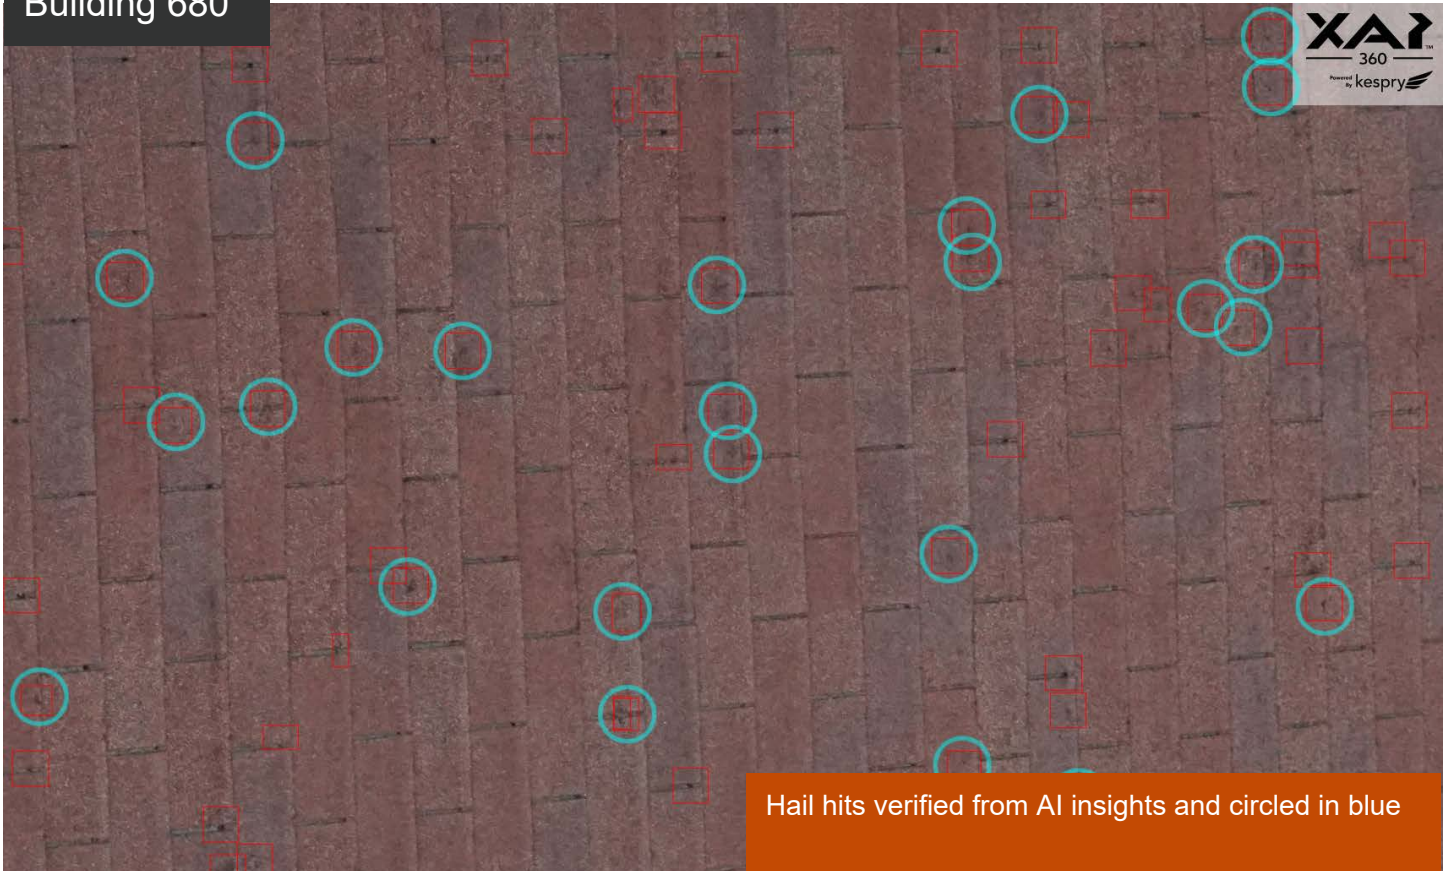
Building 680

Hail hits verified from AI insights and circled in blue

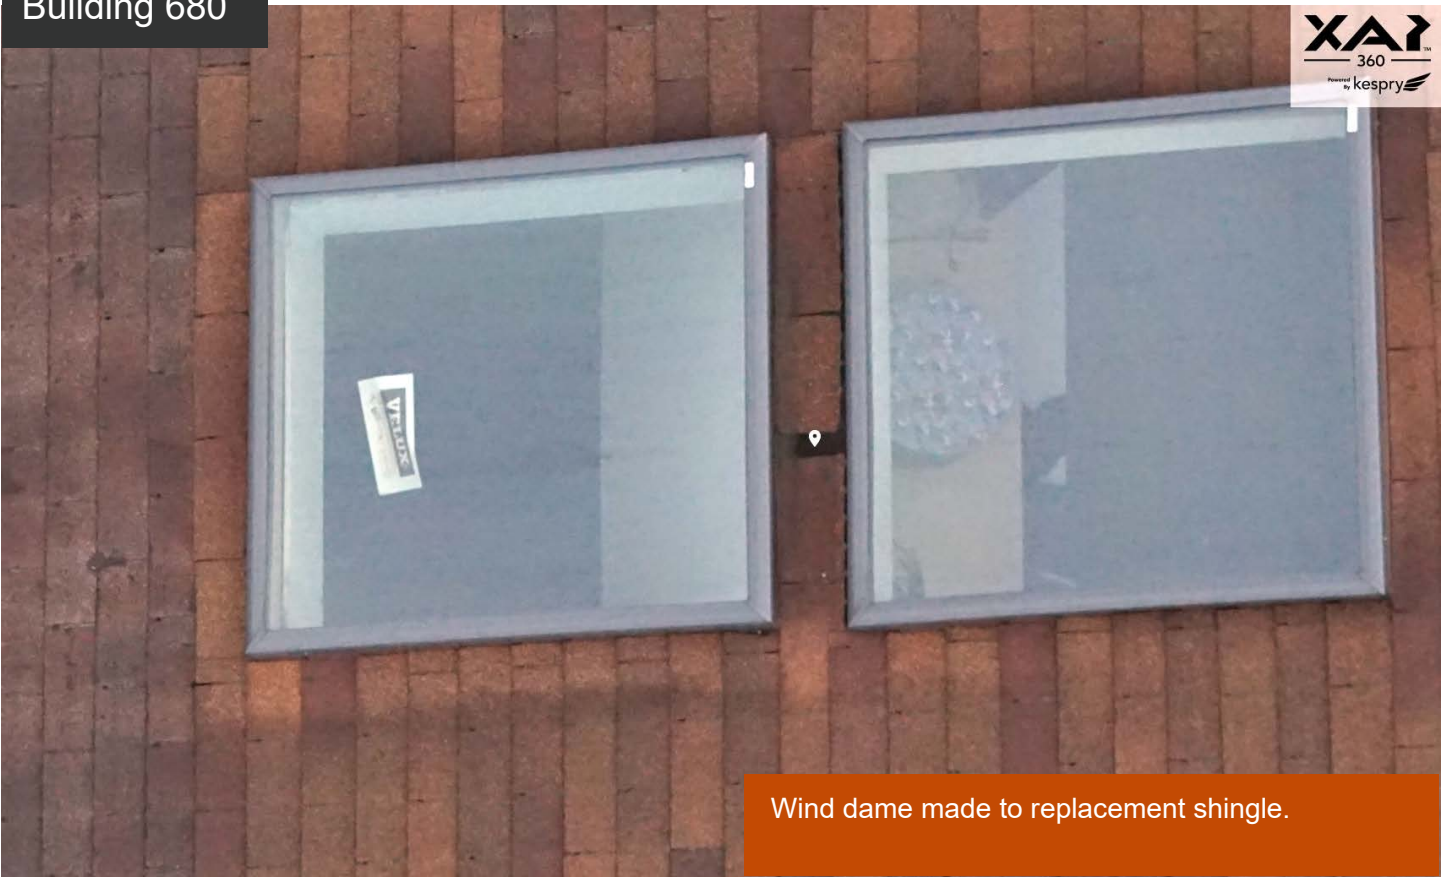
Building 680

Wind dam made to replacement shingle.

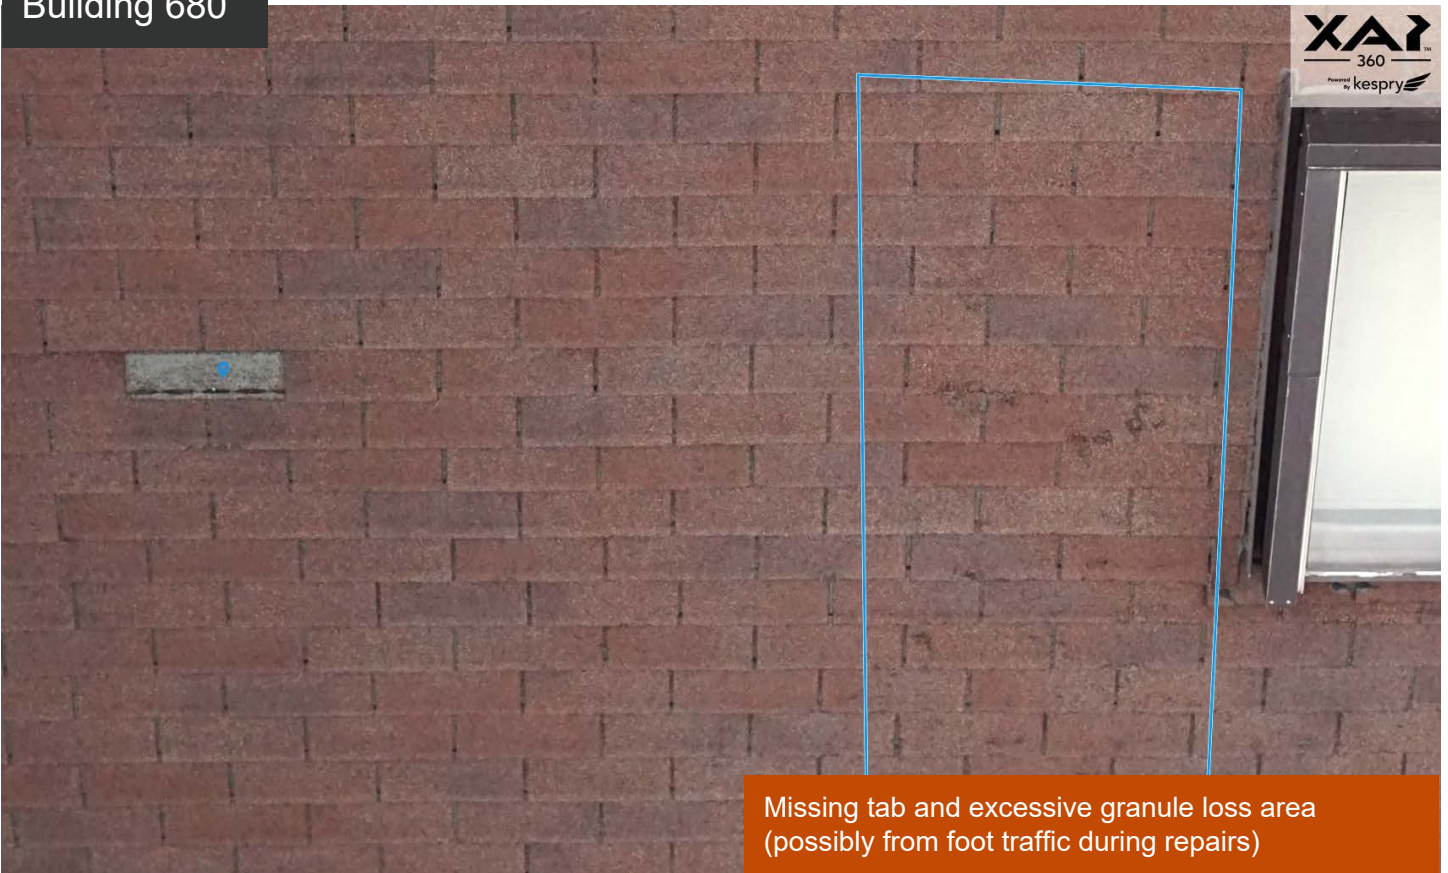
Building 680

Missing tab and excessive granule loss area (possibly from foot traffic during repairs)

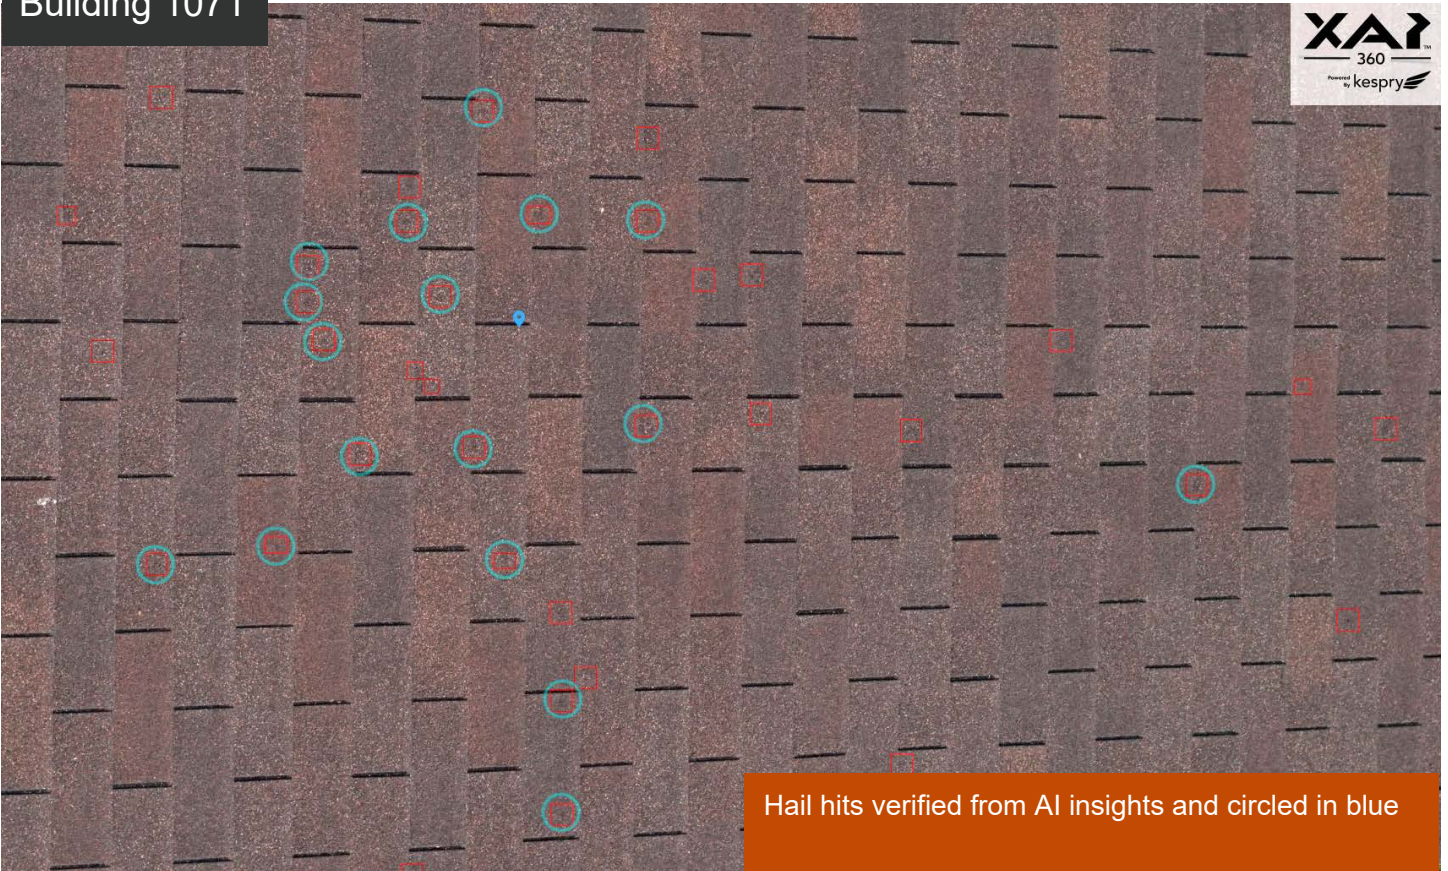
Building 1071

Hail hits verified from AI insights and circled in blue

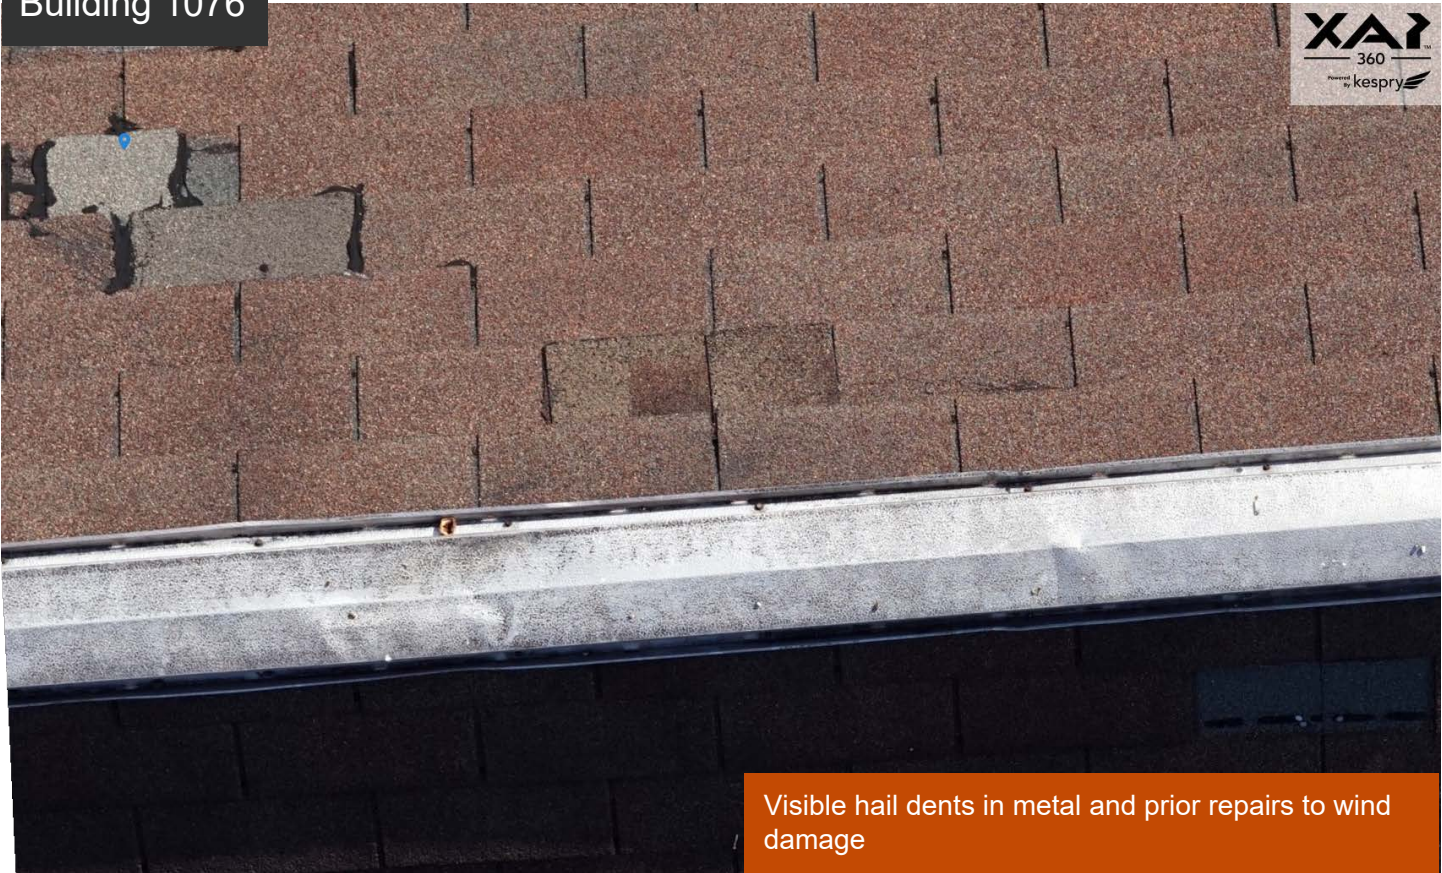
Building 1076

Visible hail dents in metal and prior repairs to wind damage

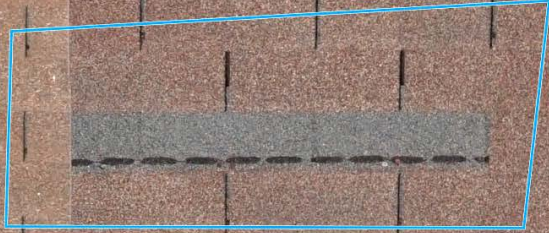
Building 1076

Blow-off

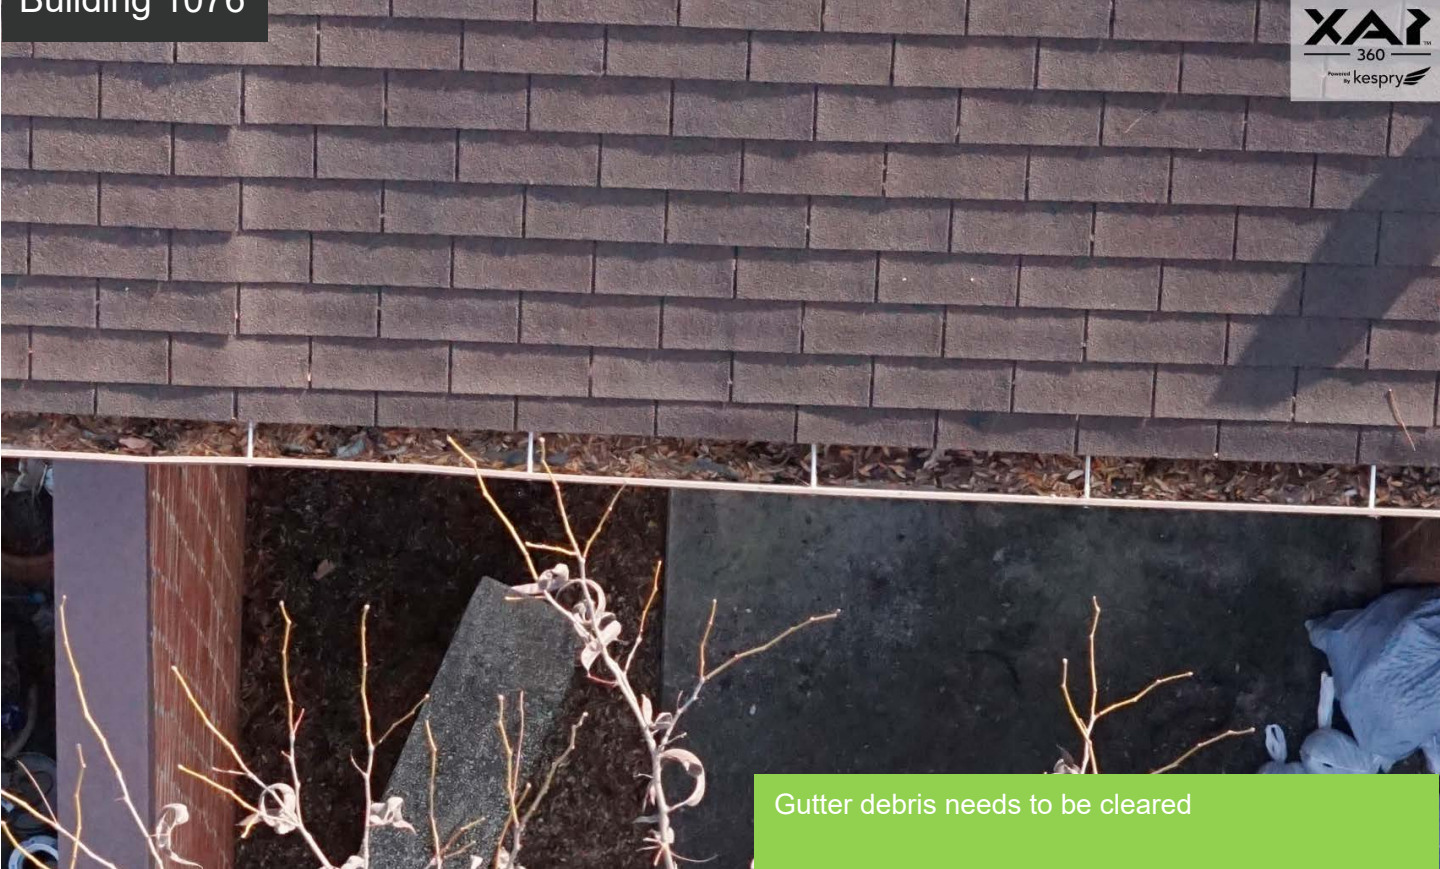
Building 1076

Gutter debris needs to be cleared

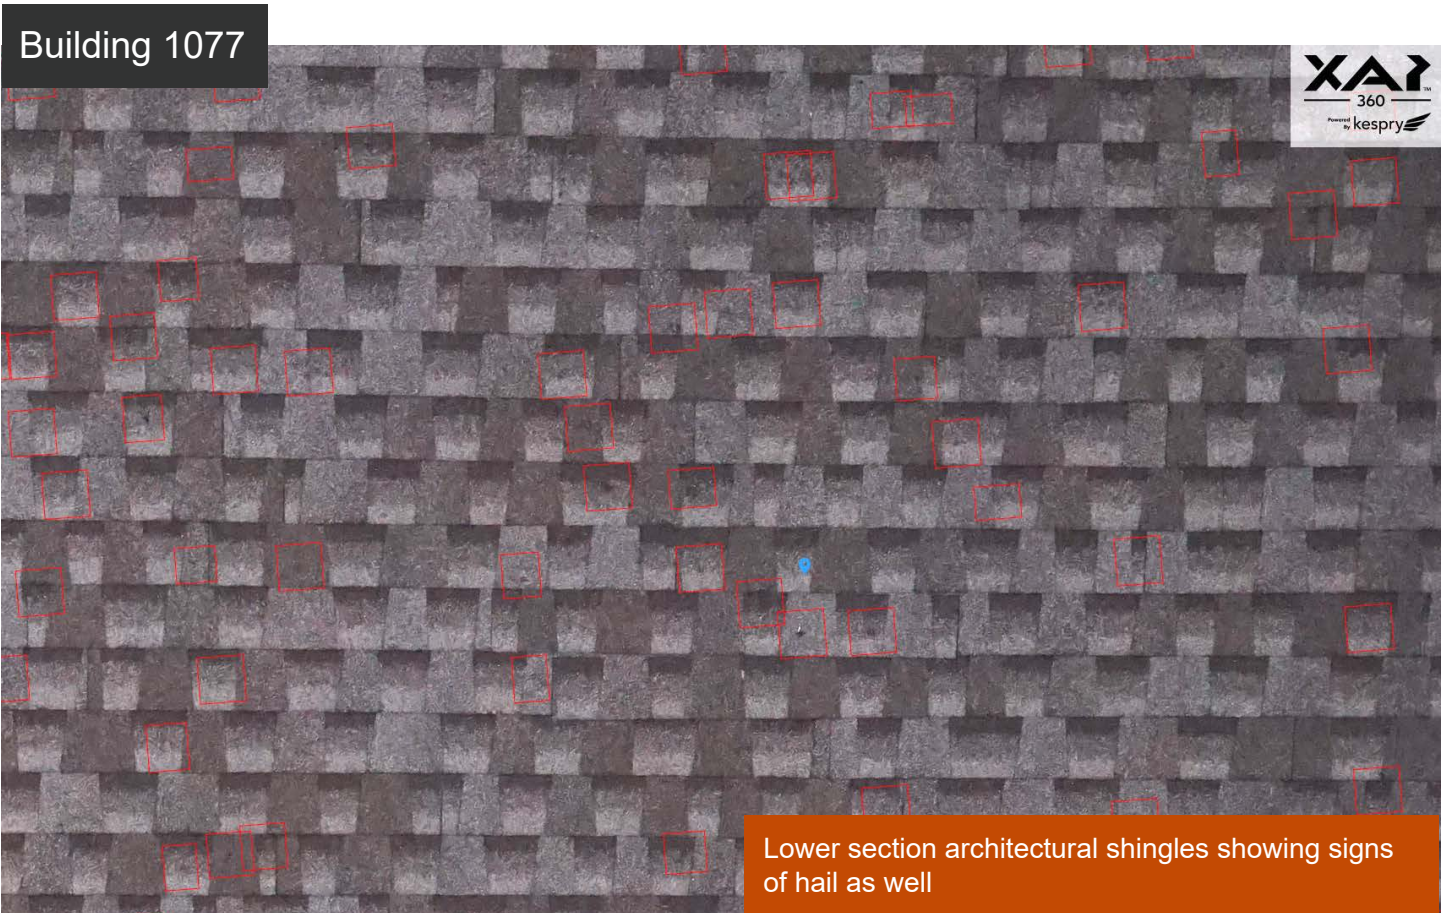
Building 1077

Lower section architectural shingles showing signs of hail as well
